# **WATERSHED BIOASSESSMENT REPORT**

## **WEST CENTRAL MORGAN COUNTY WATERSHED**

**Lambs Creek  
Sycamore Creek  
Highland Creek**

**April and October 2002**

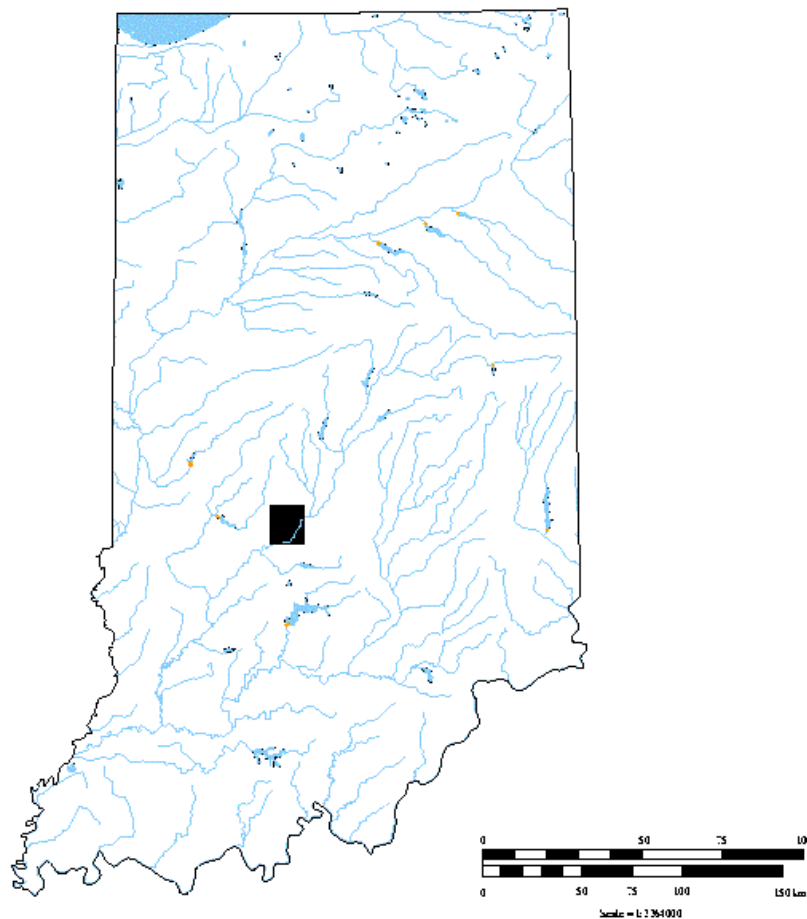
Figure 1.

The streams in this watershed (Fig. 1) lie in the "Eastern Corn Belt Plain" ecoregion of the Central U.S. This area is composed of a glacial till plain mantled in many places with loess. Stream valleys are generally shallow with narrow valley floors. Constructed ditches and channelized streams are common because much of the ecoregion has poorly drained soils. The natural vegetation consists of a mosaic of bluestem prairie and oak/hickory forest. However, a great majority of the land in this ecoregion is used for agriculture, primarily for corn and soybeans [3].
